Councillor Request Inquiry

29-2018

Cost of Collisions 2016

Animal Collisions

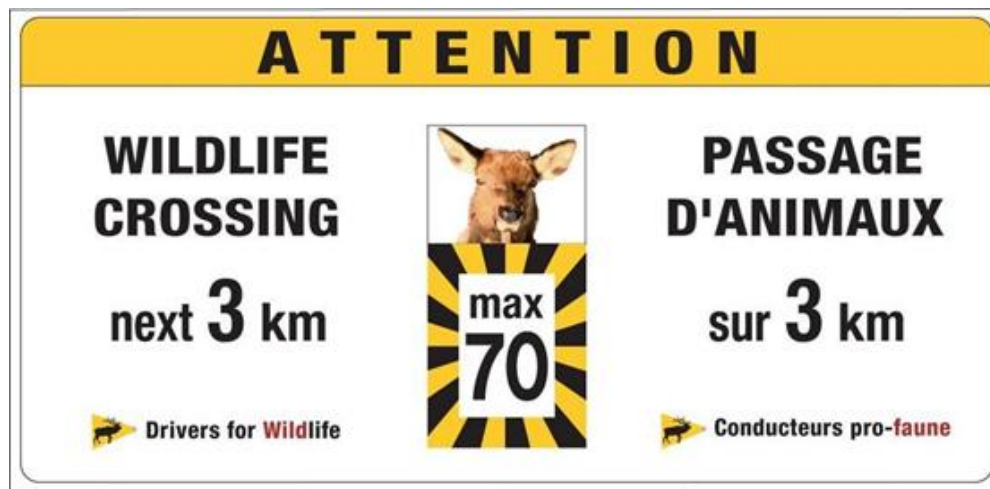
Large or enhanced animal warning signs similar to National Parks' signs may take many forms. They can be larger than the standard wildlife warning signs, include graphic images, and have permanently activated flashing amber warning lights, light emitting diodes (LEDs), or red flags attached to the signs (Figure 1, and Figure 2)

Figure 1: Roadside sign along Highway in Jasper National Park

The Parks Canada Drivers for Wildlife program in Jasper National Park combines public education, which includes bumper stickers and roadway billboards, with two digital signs that record speed and advise drivers to slow down in the high-risk wildlife zone. The number of road-killed animals along park highways decreased by about 15 percent after the first 10 months of the public education and roadside sign program; however, the signs were given the most credit for the reduction of Wildlife vehicle collisions.

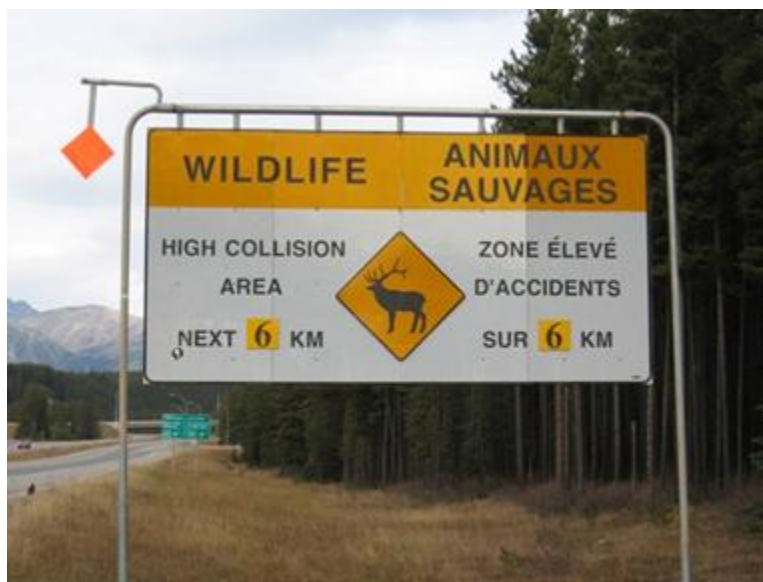
Figure 2: Large Elk warning sign along Trans-Canada Highway in Banff National Park
