**STRATHCONA
COUNTY**

Sherwood Drive and Broadmoor Boulevard Traffic Circle Report

September 2019

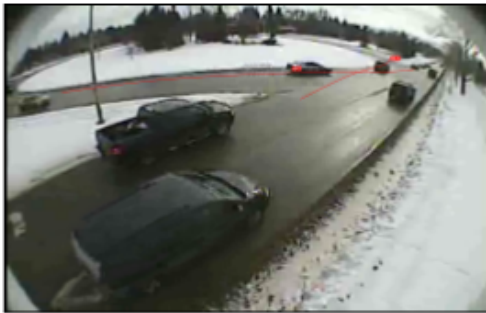
Detail 1: Southbound Vehicle Entering at Northwest Approach vs Vehicle Circulating in Roundabout @ Sherwood Dr and Broadmoor Blvd - Strathcona County - AB - February 24 2015
@ 00:00 - February 24 2015 @ 24:00 (24 hours)

Risk Level	Critical Risk	High Risk	Medium Risk	Low Risk
Measured Frequency	0	2	84	8
Annual Estimate	0	730	30660	2920
Conflict Rate (%)	0	0.02	0.75	0.07
Relative Risk	NA	NA	NA	NA

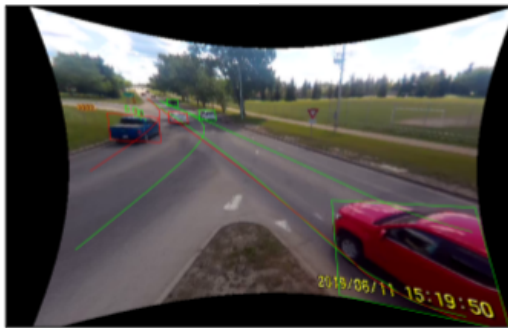
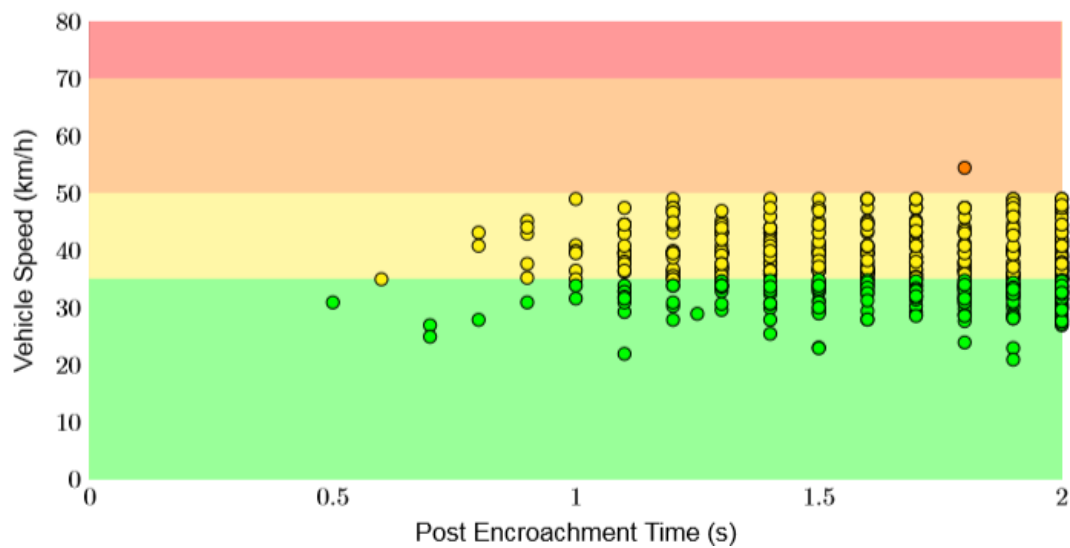
**Detail 1: Southbound vehicle entering roundabout vs Westbound vehicle in roundabout (NW)
@ Sherwood Dr and Broadmoor Blvd - Strathcona County - AB - June 11 2019 @ 00:00 - June 14
2019 @ 09:00 (81 hours)**

Risk Level	Critical Risk	High Risk	Medium Risk	Low Risk
Measured Frequency	0	1	347	176
Annual Estimate	0	122	42218	21413
Conflict Rate (%)	0	0	1.02	0.52
Relative Risk	NA	NA	NA	NA

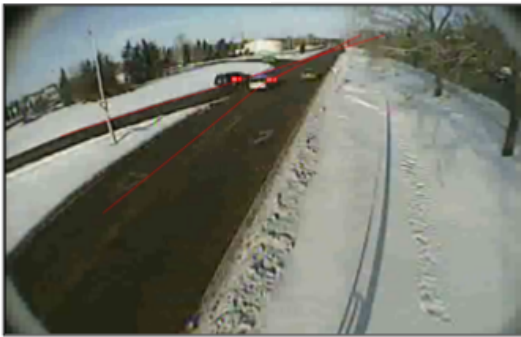
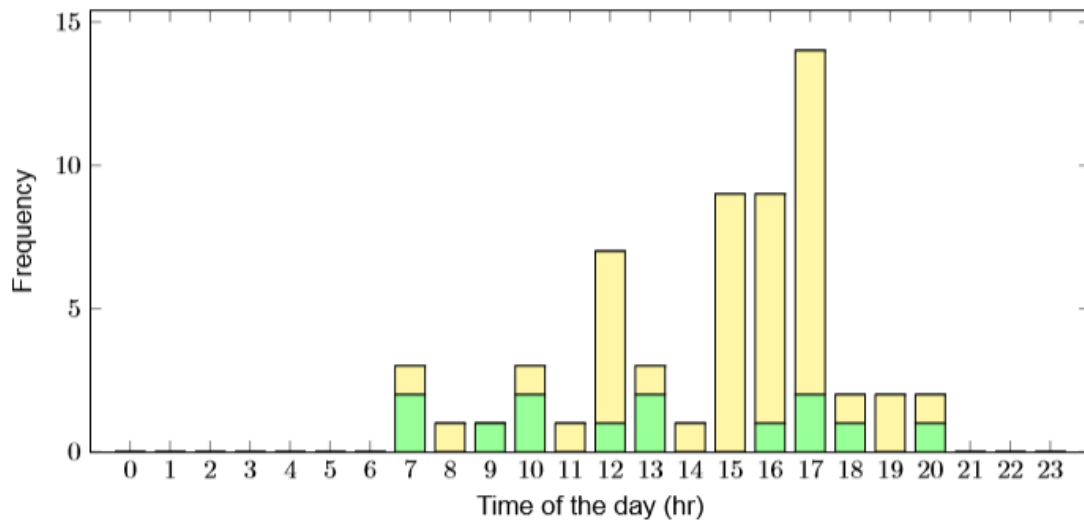
Detail 2: Northbound Vehicle Entering at Southeast Approach vs Vehicle Circulating in Roundabout @ Sherwood Dr and Broadmoor Blvd - Strathcona County - AB - February 24 2015
@ 00:00 - February 24 2015 @ 24:00 (24 hours)

Risk Level	Critical Risk	High Risk	Medium Risk	Low Risk
Measured Frequency	0	0	45	13
Annual Estimate	0	0	16425	4745
Conflict Rate (%)	0	0	0.4	0.11
Relative Risk	NA	NA	NA	NA

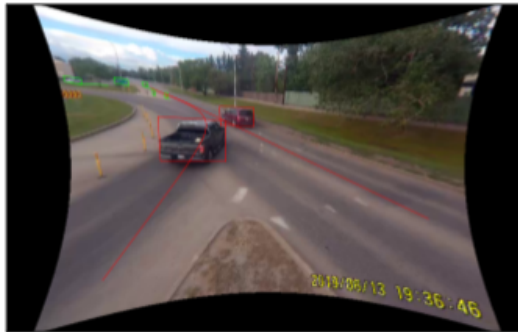
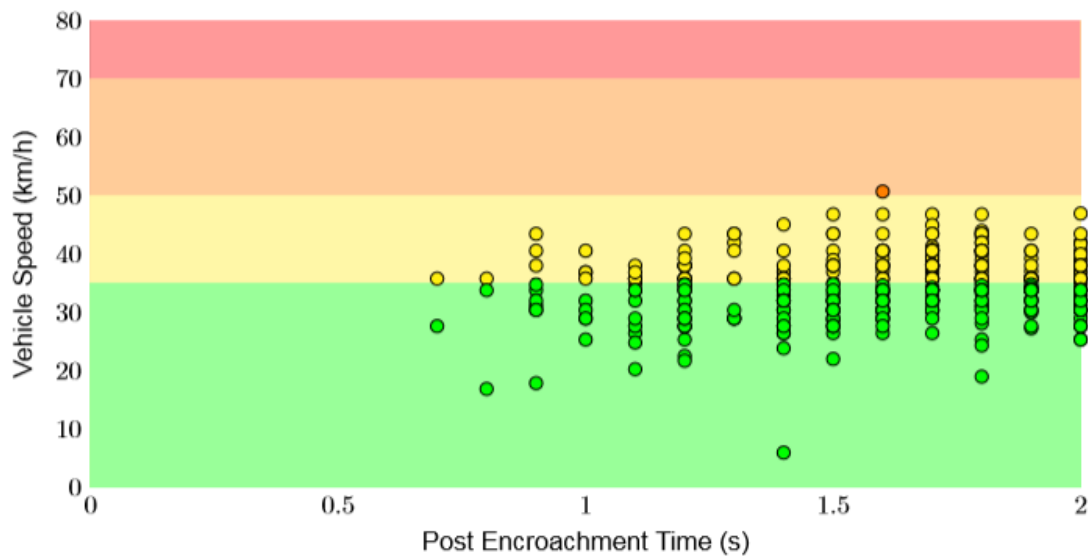
Detail 2: Northbound vehicle entering roundabout vs Eastbound vehicle in roundabout (SE) @ Sherwood Dr and Broadmoor Blvd - Strathcona County - AB - June 11 2019 @ 00:00 - June 14 2019 @ 09:00 (81 hours)

Risk Level	Critical Risk	High Risk	Medium Risk	Low Risk
Measured Frequency	0	1	154	208
Annual Estimate	0	122	18737	25307
Conflict Rate (%)	0	0	0.39	0.53
Relative Risk	NA	NA	NA	NA

The slight increase of risk on one of the eight indicators is likely attributable to the fact that the south arc traffic is concentrated in one lane, providing lower average headways in which entering vehicles attempt to find gaps. As a result, entering vehicles are more aggressive in inserting themselves in front of circulating vehicles instead of yielding.
