Encl 1 - CN Rail Safety Assessment Report.docx

Prepared by
Tahir Hameed, M.Eng, P.Eng, PTOE
Traffic Safety Engineer

Transportation Planning and Engineering Department
Strathcona County

Safety Assessment for Grade Crossing CN MILE 10.02 @ Township Road 515

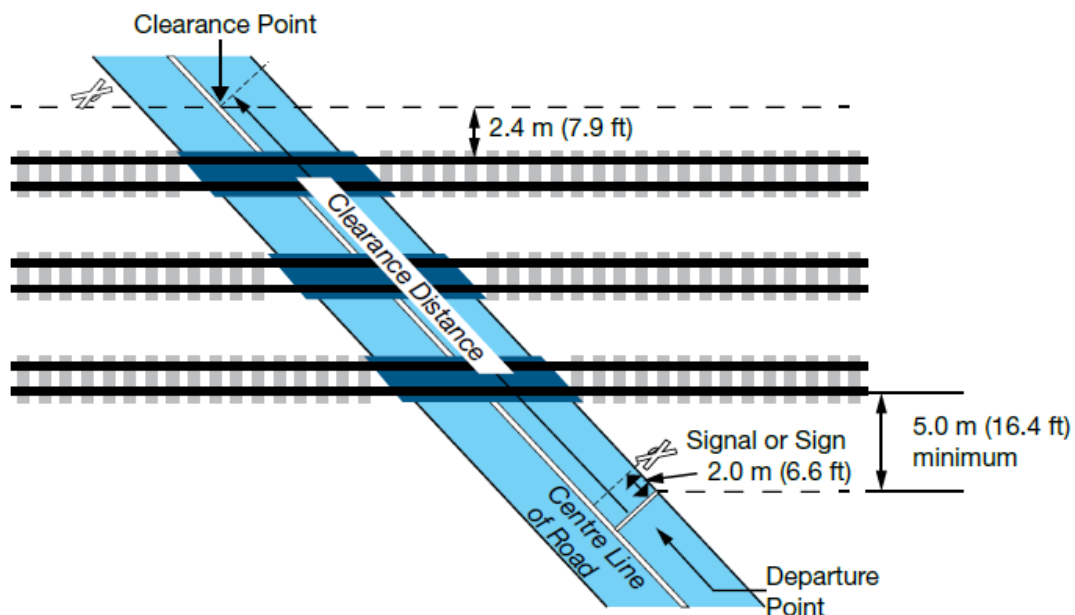
- Design vehicle – WB-20 (Tractor-Semitrailer)
- Clearance Distance – Distance between the departure point in advance of crossing to the clearance point beyond the farthest rail
 - $Cd = 11.5 \text{ m}$

- Vehicle Travel Distance – Total distance; design vehicle must travel during acceleration to pass completely through the clearance distance;
 - $S = Cd + L$; Cd =clearance distance, L =length of design vehicle

- $S = 34.2\text{m}$
- Departure Time – Time required for design vehicle (T_D) or pedestrian (T_P) to pass completely through clearance distance (cd) from stopped position

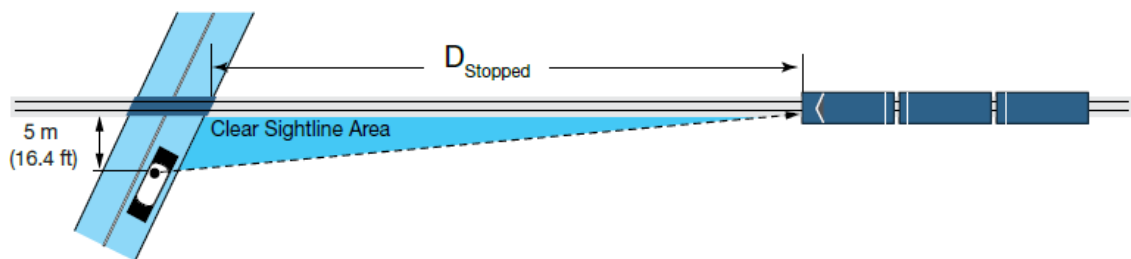
- For a stop-controlled railway crossing, D_{stopped} is the minimum distance along the line that a motorist needs to see approaching railway equipment, from the stopped position.
- $D_{\text{stopped}} = 240\text{m}$;
- Sightlines are clear for motorists on either side of the crossing.

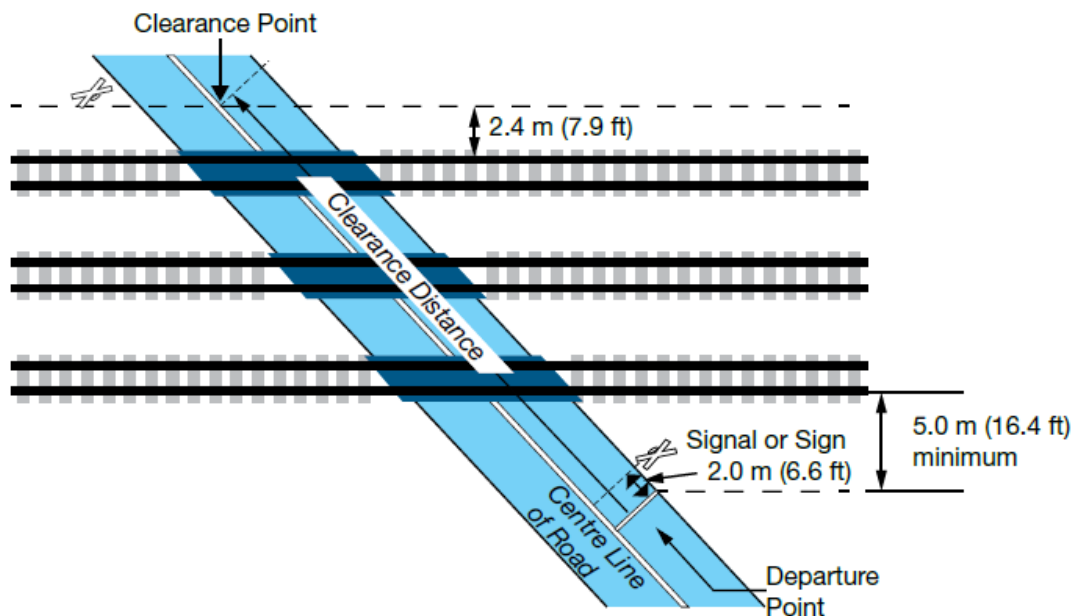
- Design vehicle – WB-20 (Tractor-Semitrailer)
- Clearance Distance – Distance between the departure point in advance of crossing to the clearance point beyond the farthest rail
 - $Cd = 10.5$ m

- Vehicle Travel Distance – Total distance; design vehicle must travel during acceleration to pass completely through the clearance distance;
 - $S = Cd + L$; Cd =clearance distance, L =length of design vehicle

- $S = 33.2$ m
- Departure Time – Time required for design vehicle (T_D) or pedestrian (T_P) to pass completely through clearance distance (cd) from stopped position

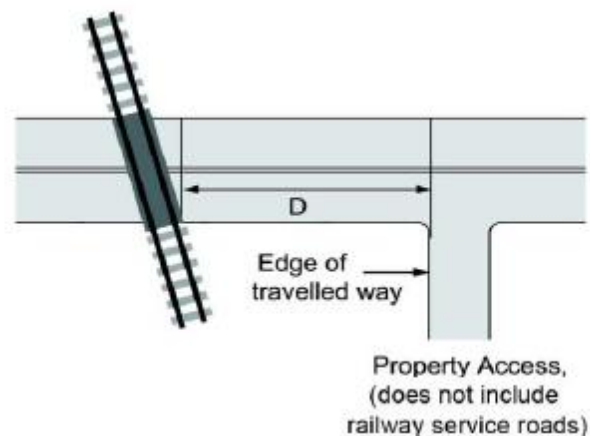
- Public grade crossing where the design speed is more than 25 km/h must be constructed 30m away from the intersecting road or entrance way according to section 11.1 of GCS.
- There is a private access located 20m south of the crossing, between the warning signal and the crossing, and is not safe for vehicles coming out of the access. Although access relocation is not required for whistle cessation but is recommended for safety reasons.

- Based on the field investigation, the presence of access in close proximity of the crossing may be hazardous considering the vehicles exiting out of the access have no prior warning before crossing since the warning system is away from the access.

- It is recommended to install 'NO TRAIN WHISTLE' tabs under existing Railway Crossing Ahead warning signs on either side of crossing.
- Relocate existing private access away from the crossing to at least south of the warning system

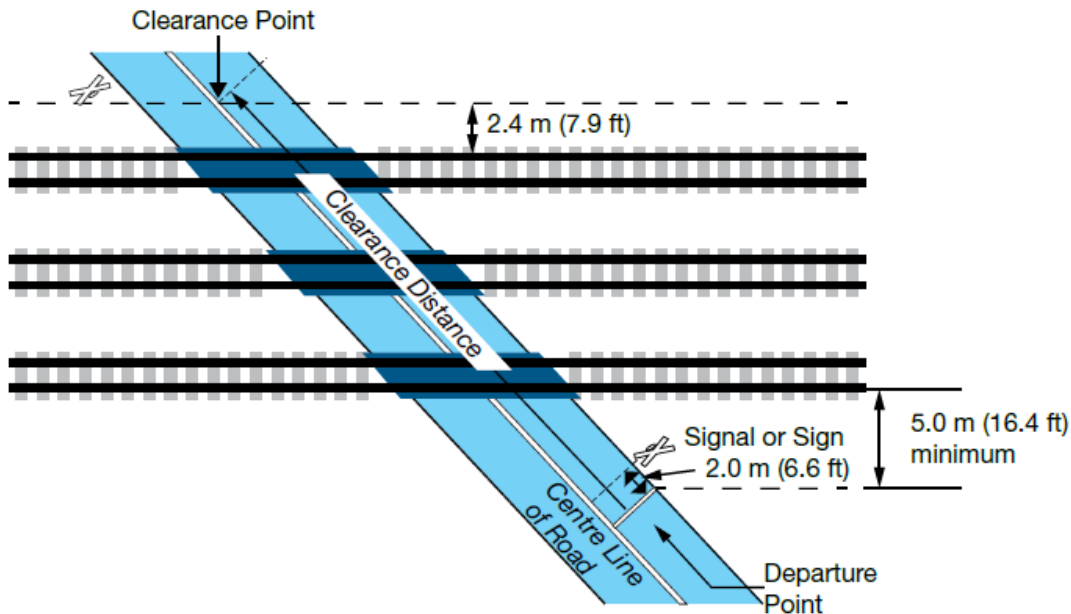
- Design vehicle – WB-20 (Tractor-Semitrailer)
- Clearance Distance – Distance between the departure point in advance of crossing to the clearance point beyond the farthest rail
 - $Cd = 70 \text{ m}$

- Vehicle Travel Distance – Total distance; design vehicle must travel during acceleration to pass completely through the clearance distance;
 - $S = Cd + L$; Cd =clearance distance, L =length of design vehicle

- $S = 92.7 \text{ m}$
- Departure Time – Time required for design vehicle (T_D) or pedestrian (T_P) to pass completely through clearance distance (cd) from stopped position

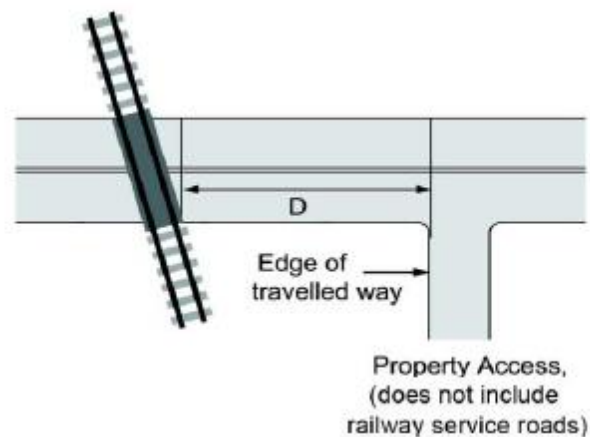
- Public grade crossing where the design speed is more than 25 km/h must be constructed 30m away from the intersecting road or entrance way according to GCS Section 11.1.
- There is a private access located 20m east of the crossing, not compliant with current standards, but does not require relocation for whistle cessation.

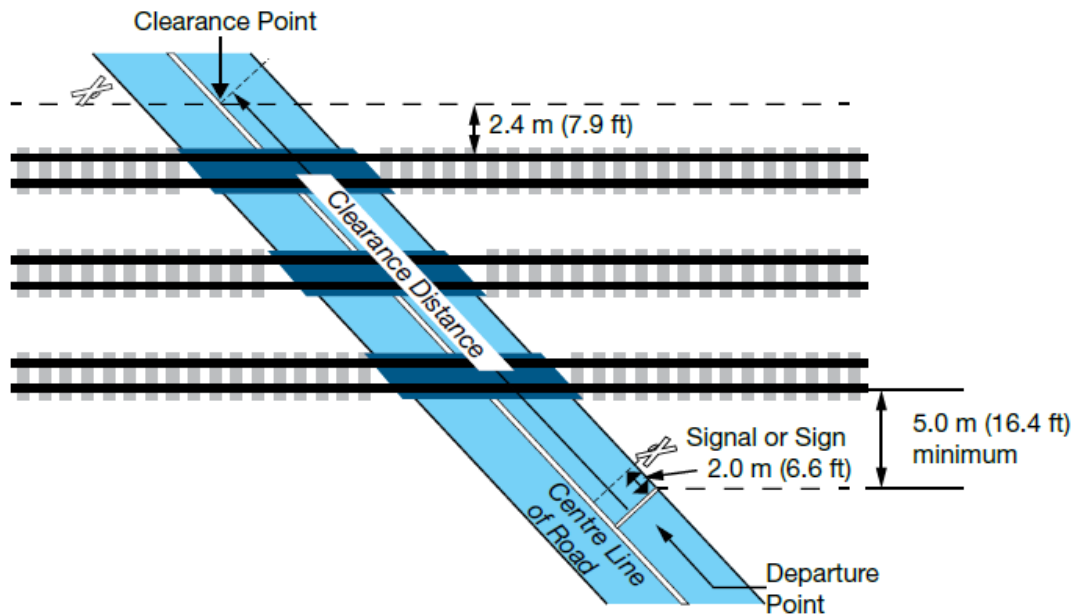
- Design vehicle – WB-20 (Tractor-Semitrailer)
- Clearance Distance – Distance between the departure point in advance of crossing to the clearance point beyond the farthest rail
 - **Cd** = 11.8 m

- Vehicle Travel Distance – Total distance; design vehicle must travel during acceleration to pass completely through the clearance distance;
 - $S = Cd + L$; Cd =clearance distance, L =length of design vehicle

- $S = 34.5$ m
- Departure Time – Time required for design vehicle (T_D) or pedestrian (T_P) to pass completely through clearance distance (cd) from stopped position

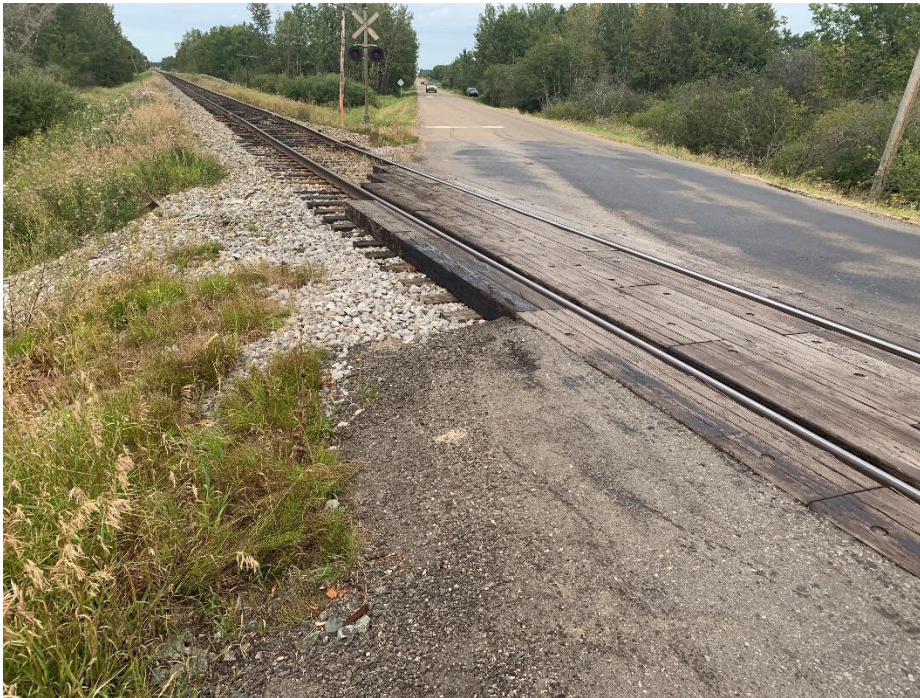
Figure 1: Range Road 232 looking north

- The surface material is made up of wood
- Road surface – Asphalt
- Flangeway width is 70 mm and depth is 140 mm
- Field side gap is 40mm
- Flangeway width, depth and field side gap satisfies current GCS.
- There is a gap in the road surface on the southwest side of the railway crossing, may be hazardous for some vehicles

- Based on the field investigation, there is gap in the south approach, may be hazardous for some vehicles.
- Warning sign on the north side is faded

- It is recommended to install 'NO TRAIN WHISTLE' tabs under existing Railway Crossing Ahead warning signs on either side of crossing.
- Remove faded WA-R sign on the north side, and replace with the new sign
- Repair south approach by filling asphalt to remove gap in the road surface.

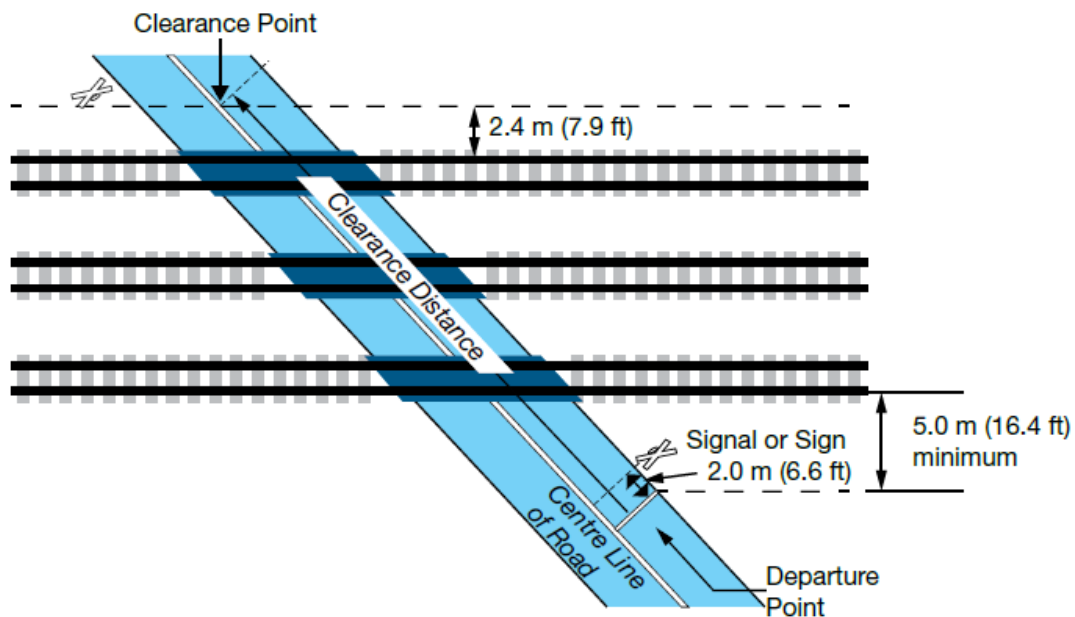
- Design vehicle – WB-20 (Tractor-Semitrailer)
- Clearance Distance – Distance between the departure point in advance of crossing to the clearance point beyond the farthest rail
 - **Cd** = 31 m

- Vehicle Travel Distance – Total distance; design vehicle must travel during acceleration to pass completely through the clearance distance;
 - **S=Cd+L**; **Cd**=clearance distance, **L**=length of design vehicle

- $S = 53.7 \text{ m}$
- Departure Time – Time required for design vehicle (T_D) or pedestrian (T_P) to pass completely through clearance distance (cd) from stopped position
- Maximum approach grade within 'S' = 0%
 - $T_D = J + T$
 - J = Perception-reaction time; 2 seconds
 - T = the time, for design vehicle to travel through clearance distance (S)
 - $T = t \times G$
 - T = the time, required for design vehicle to accelerate through the vehicle travel distance (S) from assumed acceleration curves from *Geometric Design Guide for Canadian Roads*
 - $T_D = 2 + 15 = 17 \text{ seconds}$
 - $T_P = Cd / V_P = 31 \text{ sec}$; $V_P = 1.0 \text{ m/s}$ (avg. pedestrian speed)
 - Departure Time = 17 seconds; (Greater of T_D and T_P)

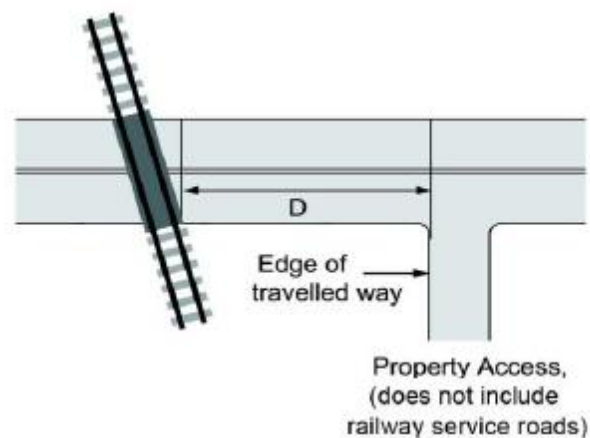
- Public grade crossing where the design speed is more than 25 km/h must be constructed 30m away from the intersecting road or entrance way according to GCS Section 11.1.
- There is a private access located 20m east of the crossing, not compliant with current standards, but does not require for whistle cessation.

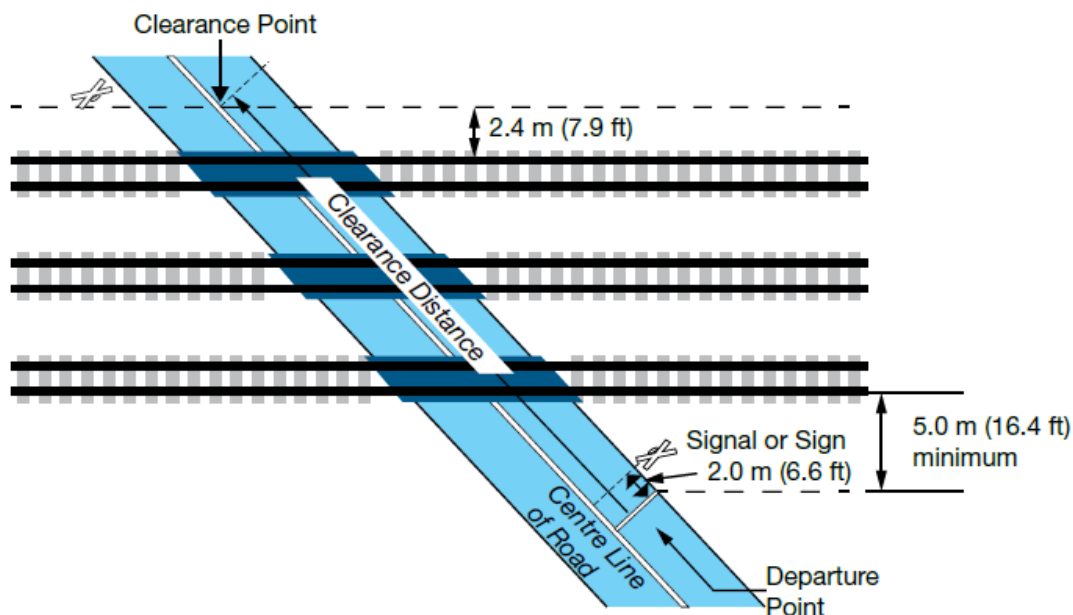
- Design vehicle – WB-20 (Tractor-Semitrailer)
- Clearance Distance – Distance between the departure point in advance of crossing to the clearance point beyond the farthest rail
 - $Cd = 17.30$

- Vehicle Travel Distance – Total distance; design vehicle must travel during acceleration to pass completely through the clearance distance;
 - $S = Cd + L$; Cd = clearance distance, L = length of design vehicle
 - $S = 40$ m
- Departure Time – Time required for design vehicle (T_D) or pedestrian (T_P) to pass completely through clearance distance (cd) from stopped position
- Maximum approach grade within 'S' = 0%

- $T_D = J + T$
 - J = Perception-reaction time; 2 seconds
 - T = the time, for design vehicle to travel through clearance distance (S)
- $T = t \times G$
 - T = the time, required for design vehicle to accelerate through the vehicle travel distance (S) from assumed acceleration curves from *Geometric Design Guide for Canadian Roads*
- $T_D = 2 + 12.2 = 14.7$ seconds
- $T_P = C_d / V_P = 17.3$ sec; $V_P = 1.0$ m/s (avg. pedestrian speed)
- Departure Time = 14.7 seconds; (Greater of T_D and T_P)
